Home Inspection Report

9912 Woodward Court, Hillsboro, OH 45133

Tuesday November 6, 2018

Integrity Building Inspections Plus, LLC
11851 Hamer Road
Georgetown, OH 45121
513-260-7909

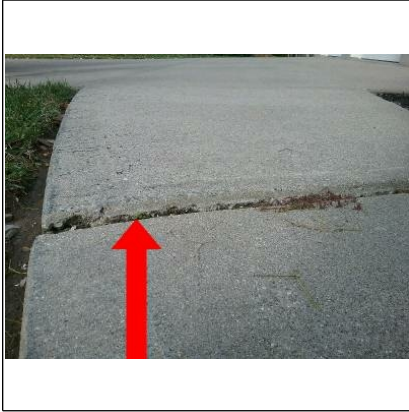
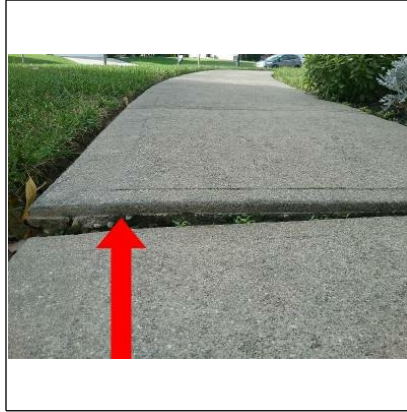
Comments Some sidewalk slabs had settled and offset creating trip hazards. I recommend these be repaired and you remain cognizant to minimize the risk of injury in the meantime.

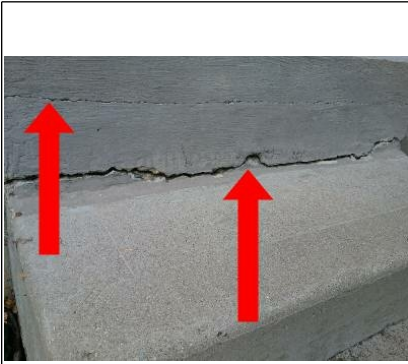
Patch maintenance was needed at the step to the front porch.

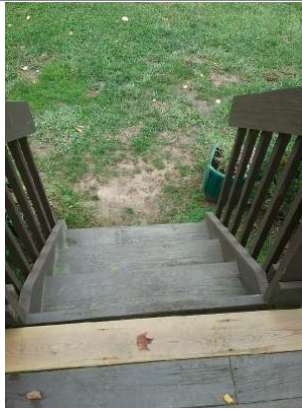
The railings were loose on the deck steps and I recommend they be properly secured.

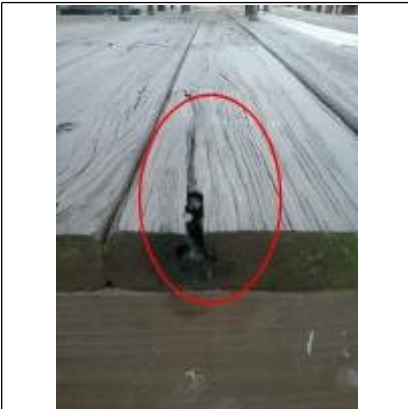
Comments The deck was showing its age and while some repairs had been made, others will be needed in the near future. I recommend making repairs as needed and applying paint or stain to prolong the useful life of the materials.

Soft, spongy floor boards.

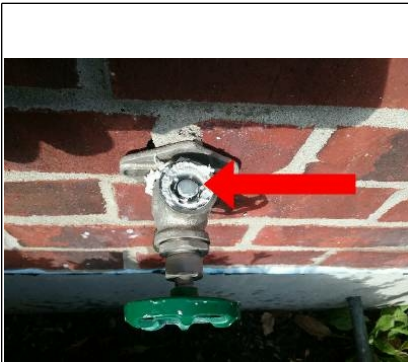
Comments While both hose bibs operated as intended, the eastern hose bib was damaged and leaked during operation only; I recommend it be repaired as needed.

Damaged atmospheric siphon break/cap.

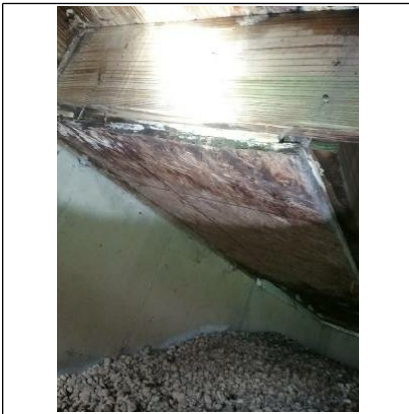
The underside of the chimney chase was untreated OSB material which had signs of moisture damage. I recommend it be repaired and painted. *Remain anticipatory of hidden defects behind the OSB.

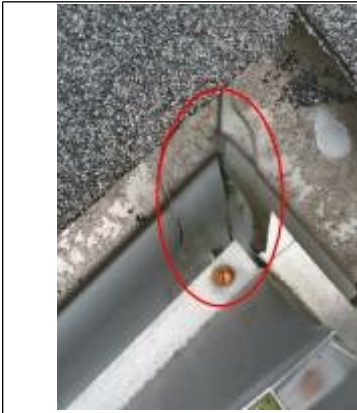
Comments The north corner of the porch gutter leaked and I recommend it be sealed.

An example of the gutter corner needing sealant maintenance.

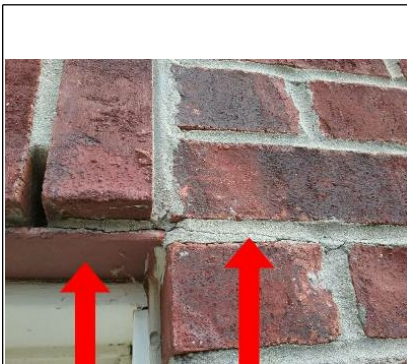
I recommend being diligent with paint maintenance to steel lintels and performing tuckpoint maintenance where cracking exists.

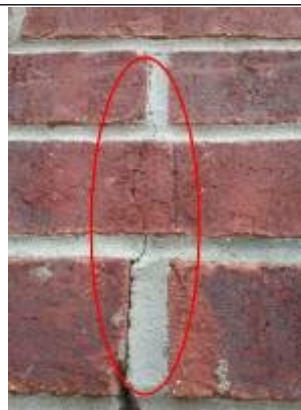
Sealant/tuckpoint maintenance needed and monitor regularly.

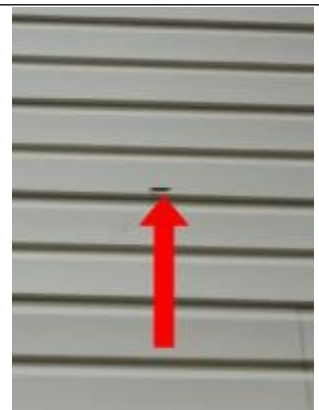
Shown here is a single hole in the siding (East side) that I recommend be repaired.

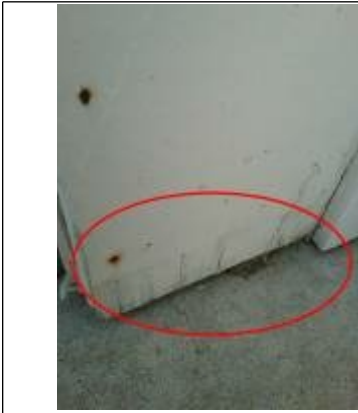
Paint maintenance was needed at overhead door openings.

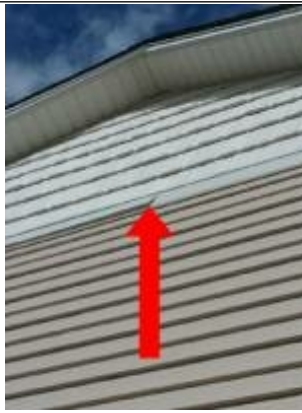
Comments The vinyl trim was in satisfactory condition; the wooden trim at the garage door openings needed paint maintenance and there was one section of aluminum trim above the garage doors that was loose. I recommend these be mitigated as necessary.

Loose aluminum trim.

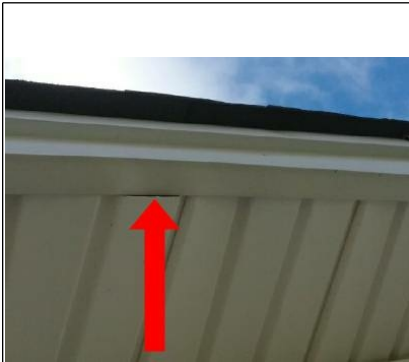
Comments The soffit on the north side was loose in two areas and I recommend they be properly secured.

Loose section.

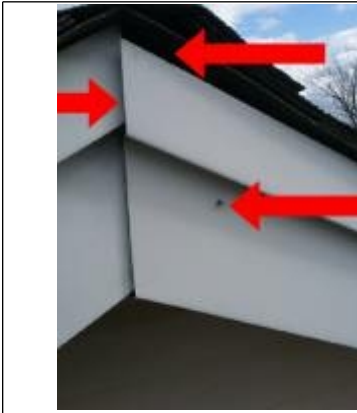
Shown here is a loose section of fascia on the south side of the house. There was an unseated face-nail and the top arrow shows a void where the roof underlayment had moisture staining. I recommend it be repaired as needed.

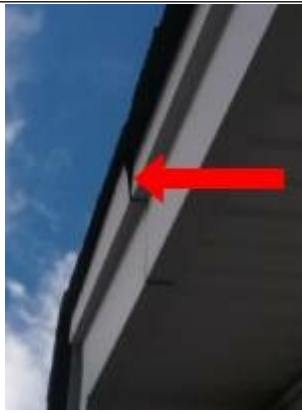
Another loose section of fascia.

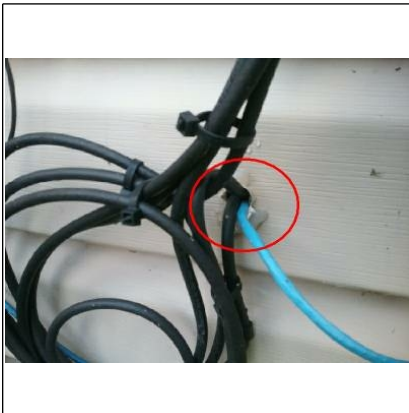
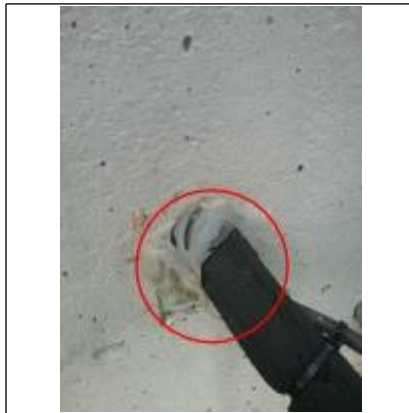
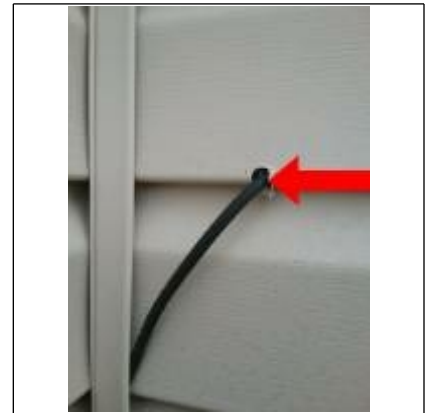
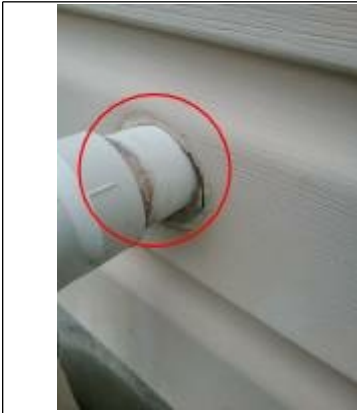
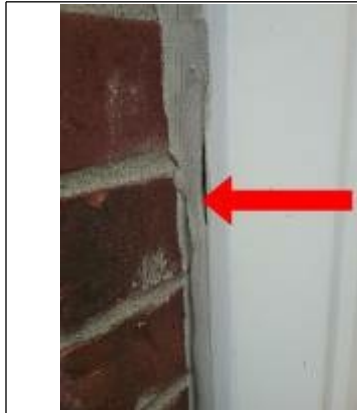
Comments Below are examples of areas in need of sealant maintenance.

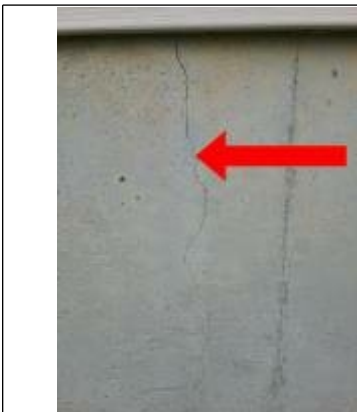
Seal shrinkage cracks and monitor.

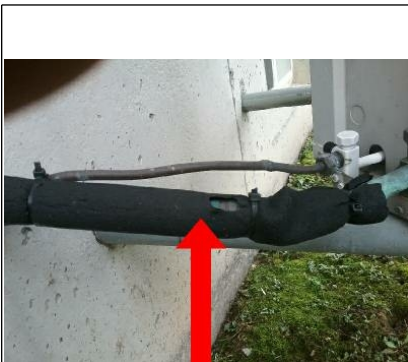
I recommend replacing the insulation on the suction line to the air conditioner for increased efficiency.

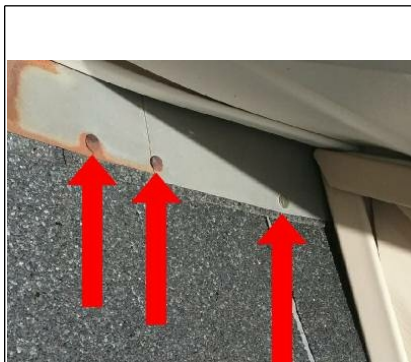
More face-nails; also note paint maintenance was needed at rusty areas.

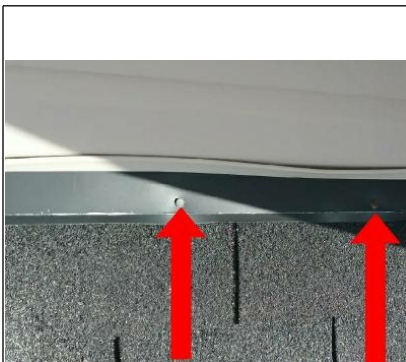
More face-nails.

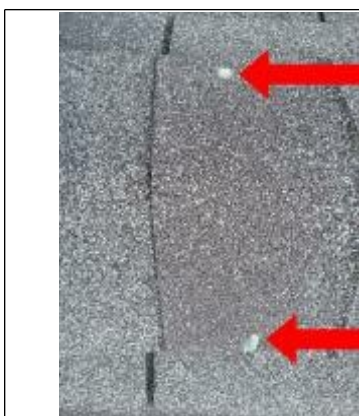
Comments The roof coverings were showing their age; some shingles were cupped, many had missing granules, there was evidence of unseated nails and a single tab was missing. I recommend these be repaired and budgeting for replacement in the near future.

More face-nails in need of sealant maintenance.

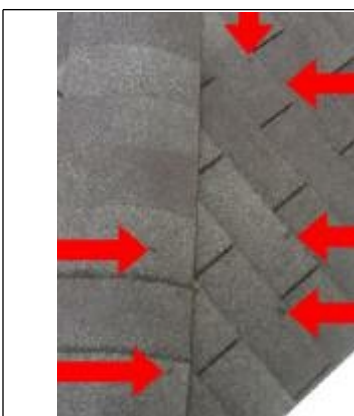
Unseated nails.

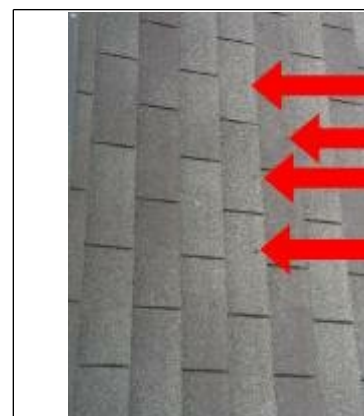
Same condition as the previous picture.

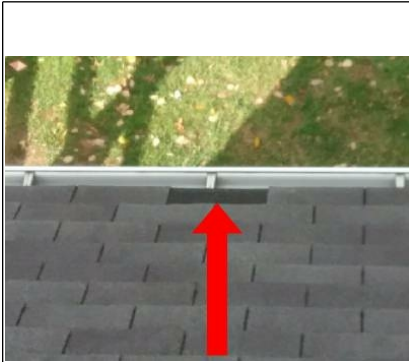
Missing tab.

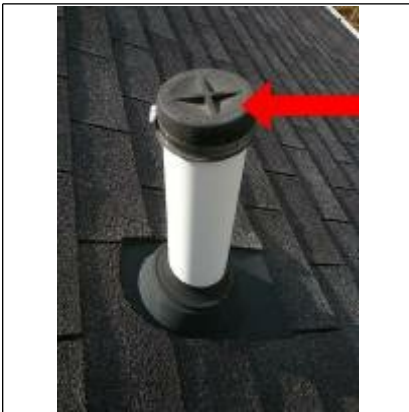
Comments The condition of the materials was satisfactory though the plumbing vent was capped. I recommend having the cap removed as no sewer gasses are currently able to escape the system as intended.

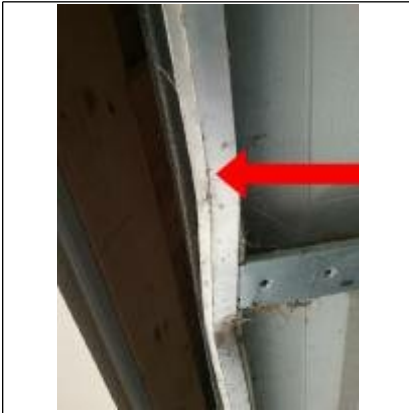
A framing member on the center door was bent though the door seated and sealed as intended.

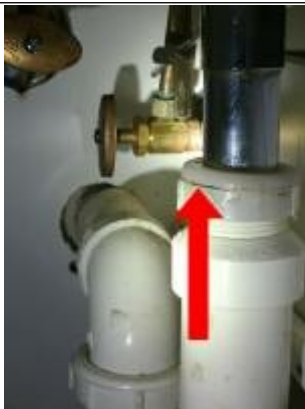
The plumbing fitting at the sink drain was cracked though no leaks were apparent; I recommend it be monitored regularly.

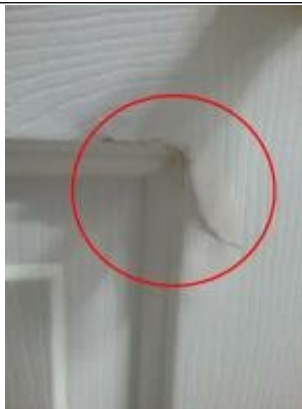
Minor damage to the door as an FYI (it appeared to have been repaired but not painted).

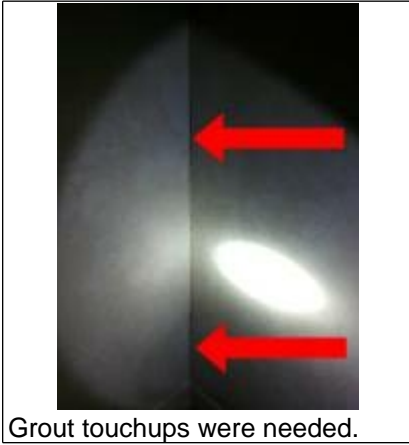
Shower/Tub area ☒ Ceramic/Plastic Condition: ☒ Satisfactory ☐ Marginal ☐ Poor ☐ Rotted floors
 Caulk/Grouting needed: ☒ Yes ☐ No
 Where: Grout touchups were needed in the shower surround.

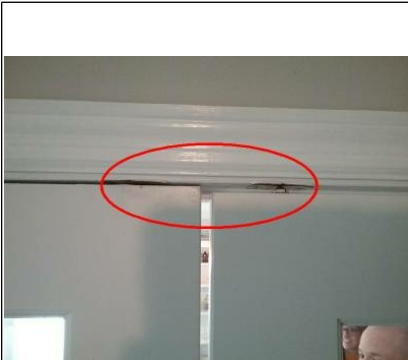
The doors were out of square and I recommend they be adjusted as needed.

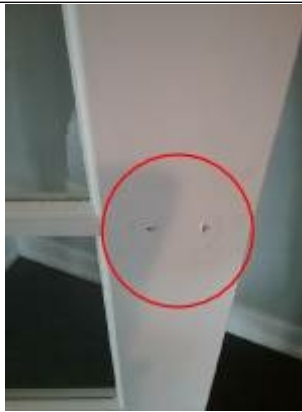
One door was missing its closure hardware and I recommend it be installed.

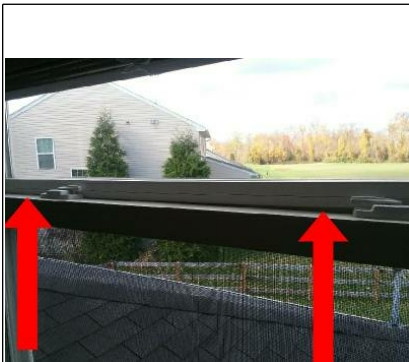
The window was out of square and did not latch closed on one side. I recommend this be mitigated as necessary.

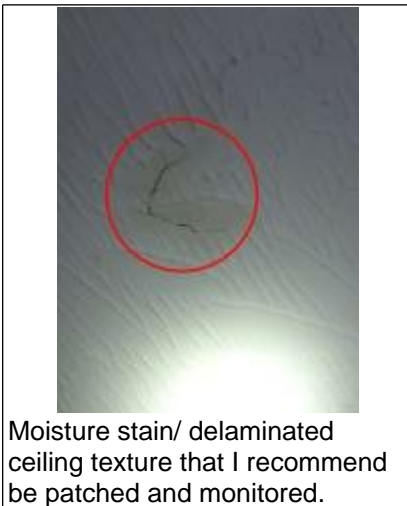
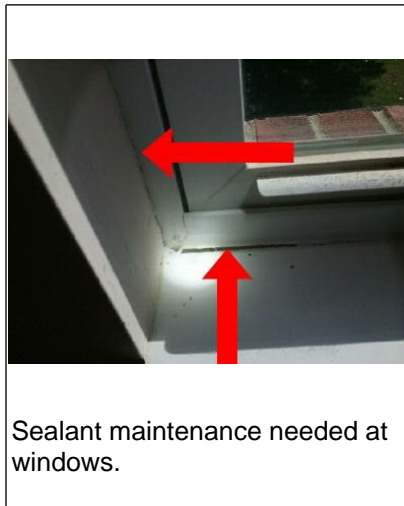
Moisture stains ☒ Yes
Where: Central to the ceiling

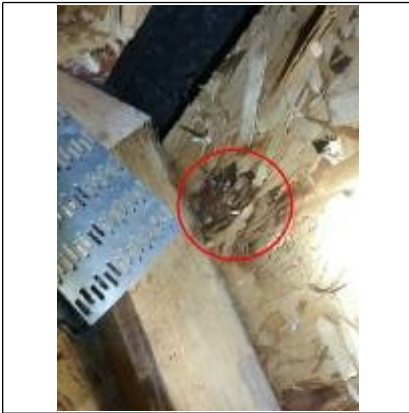
Comments There was a small water stain on the northern gable likely from unsealed face-nails. I recommend sealing these and monitoring during active precipitation.

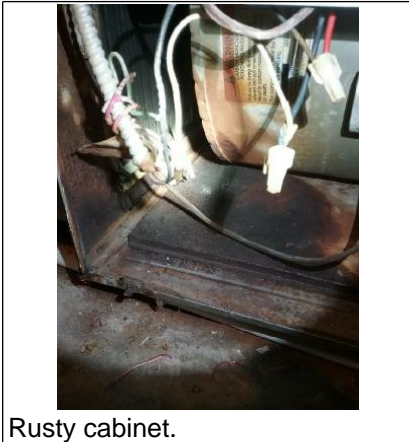
Comments This unit is marked as marginal based on its age and its rusty cabinet. I recommend having a qualified HVAC technician evaluate this for the cause of rust and to perform annual maintenance.

Rusty cabinet.

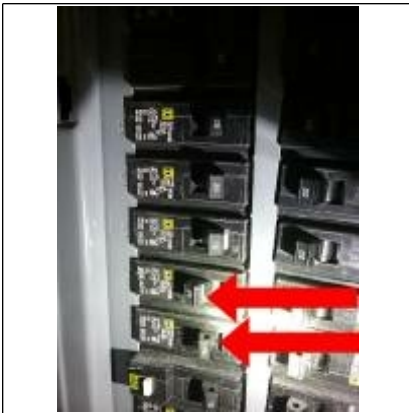
Comments This is marked as marginal because of two inoperable breakers that I recommend be evaluated by a qualified contractor for repairs.
